FUGRO LOADTEST THERMAL INTEGRITY PROFILING

THERMAL INTEGRITY PROFILING

SERVICE SHEET THERMAL INTEGRITY TESTING

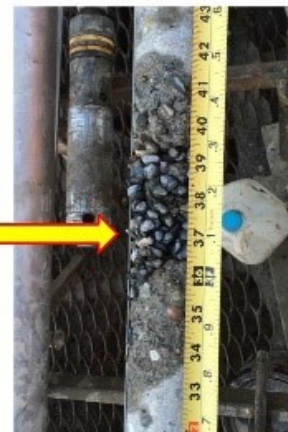
Anomalous low temperature detection investigated by coring resulting in detection of poor quality concrete.

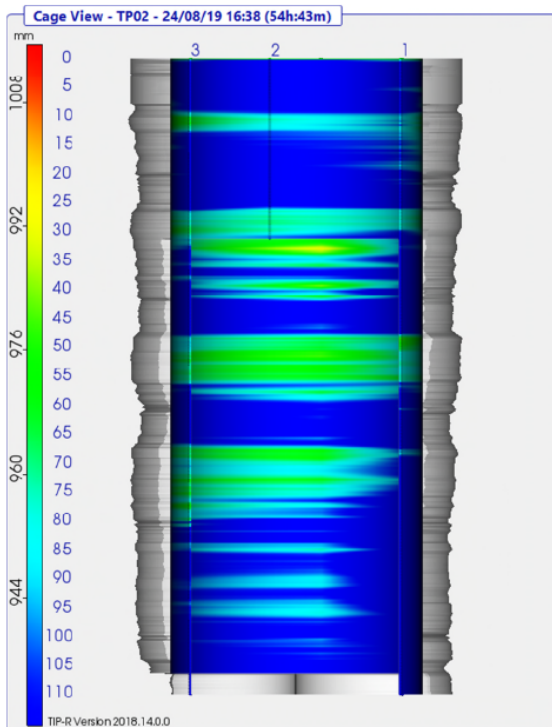
Thermal profile of 110 m long pile
